ADDENDUM NO. 1
TO THE
DRAWINGS AND PROJECT MANUAL
FOR
**2024 CY-CREEK HS RENOVATIONS
CYPRESS-FAIRBANKS ISD
CYPRESS, TEXAS**

01/30/2025

The purpose of this project was to collect and analyze bulk samples of suspect ACBM at the Cypress Creek High School campus. For the proposed renovations, EFI's sampling activities were generally limited to construction finishes impacted by the planned renovations, as noted in VLK's 50% construction drawings dated July 25, 2024. The following generalizations describe the proposed work:

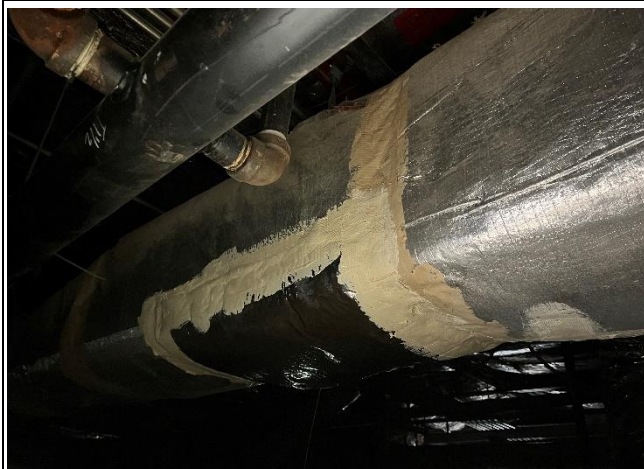
- **The cream mastic applied to duct foil/fiberglass insulation located in the kitchen and may exist in other areas throughout the campus was found to contain 5% chrysotile asbestos. (All duct with insulation in the kitchen area)**

- * The **cream mastic applied to foil/fiberglass duct insulation** located above the ceilings is considered a Category II non-friable ACBM and in its current condition the material presents a "**low**" hazard.

Photo 01: ACM Tan/cream mastic on duct insulation

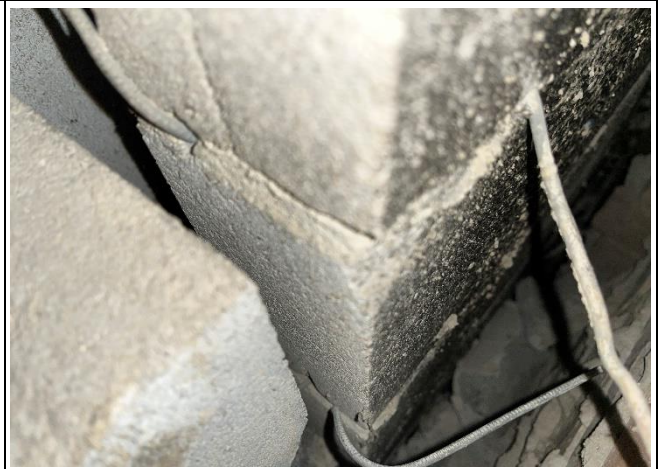
- **The black damp proofing mastic applied to CMU block walls located in the 1980's additions of the campus was found to contain 10% chrysotile asbestos.**

- * The **black damp proofing coatings on CMU behind brick veneer** is considered a Category II non-friable ACBM and in its current condition the material presents a "**low**" hazard.

Photo 02: ACM damp proofing behind brick.

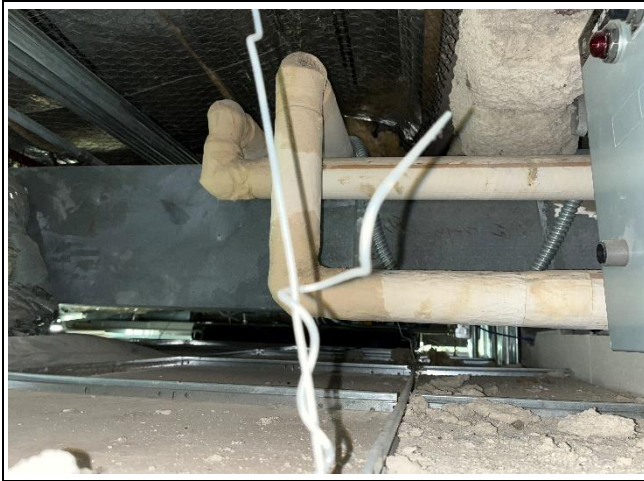
- **The heating water pipe insulation with white/cream mastic located in the (1980 additions) commons snack bar area and mechanical room was found to contain 5% chrysotile asbestos. (Approximately 200+ linear feet)**

- * The **heating and chilled water pipe insulation with cream mastic** is classified as a category II non-friable ACBM and in its current condition the material presents a "**low**" hazard.

Photo 03: ACM Heating water pipe insulation with cream mastic

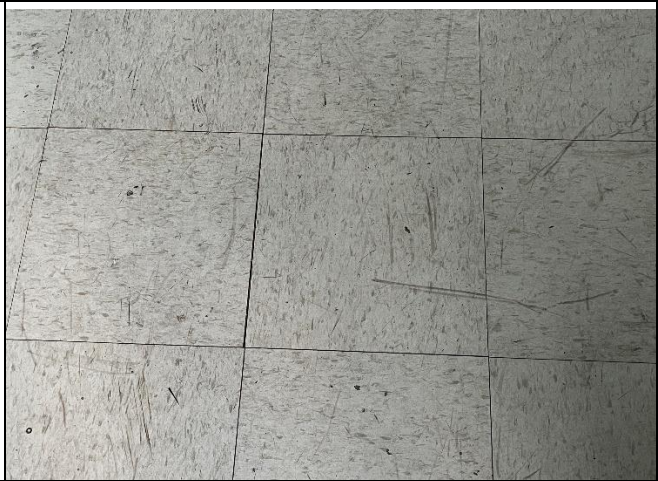
Photo 04: 12"x12" Beige vinyl floor tile with yellow mastic - nonACM

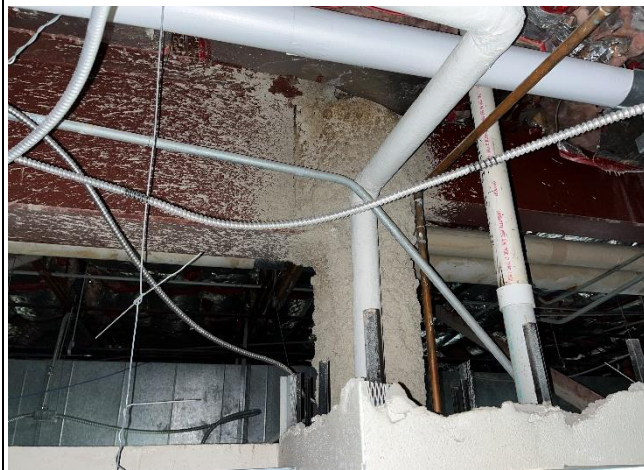
Photo 05: Fireproofing with plaster surround - nonACM

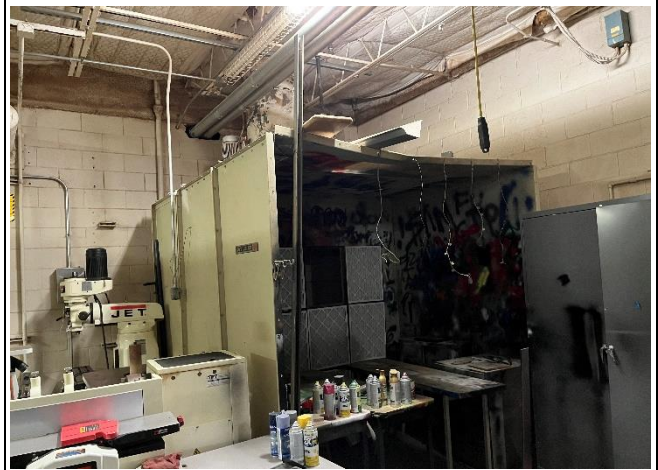
Photo 06: Paint booth in the Shop area - nonACM

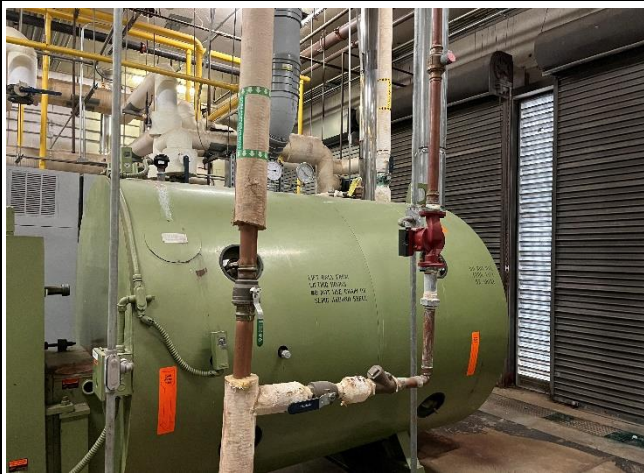
Photo 05: Domestic water boiler - nonACM

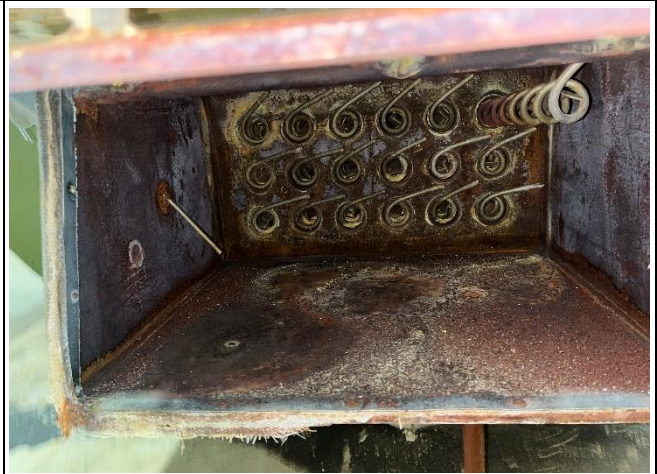
Photo 06: Domestic water boiler – nonACM

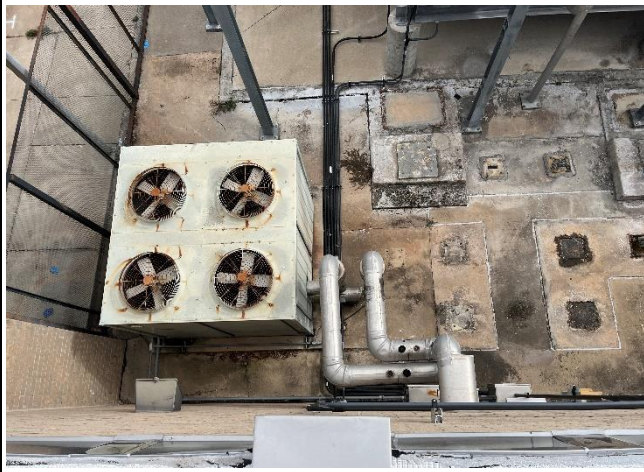
Photo 05: Air-cooled chiller and pipe insulation – nonACM

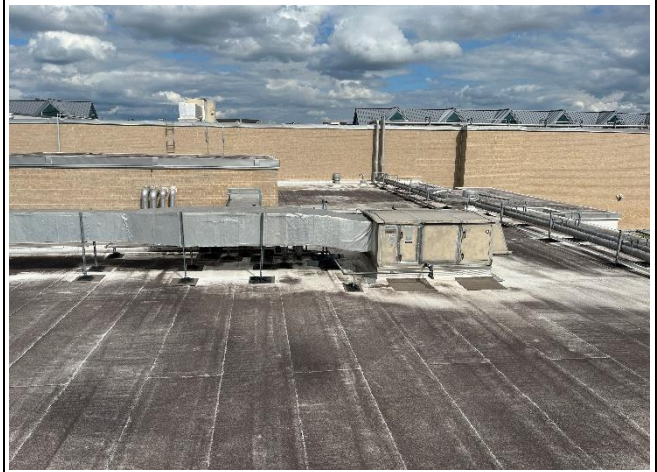
Photo 06: RTU with duct insulation and chilled / heating water pipe insulation – nonACM.

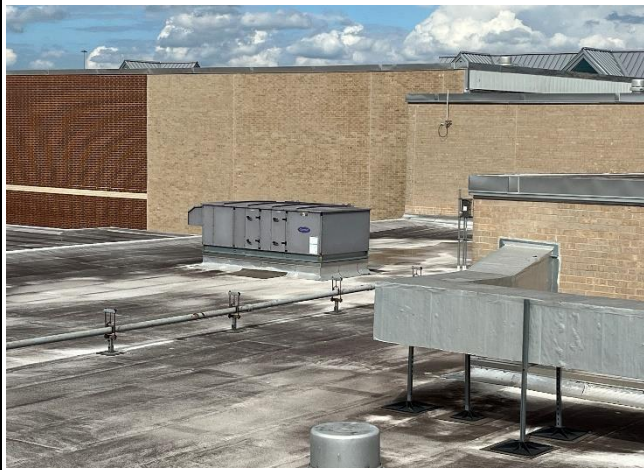
Photo 05: RTU with chilled / heating water pipe insulation – nonACM.

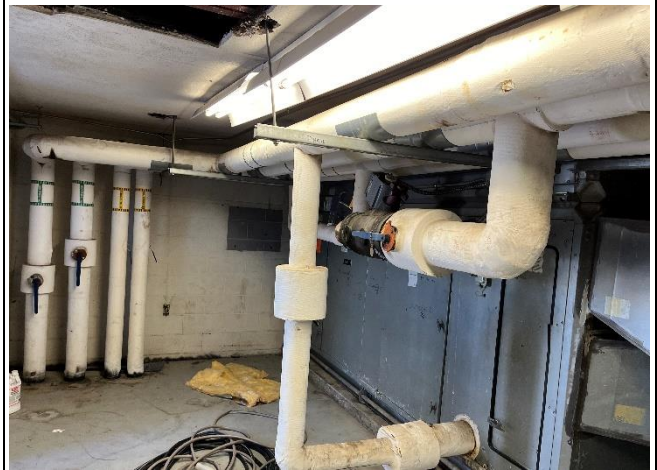
Photo 06: Penthouse mechanical room – nonACM pipe insulation and duct sealant.
